Subject:  
Long-Term Operations and Maintenance Annual Report (Soil Remedy)  
South Cavalcade Superfund Site – Concrete Cap  
Houston, Texas

Date:  
July 9, 2013

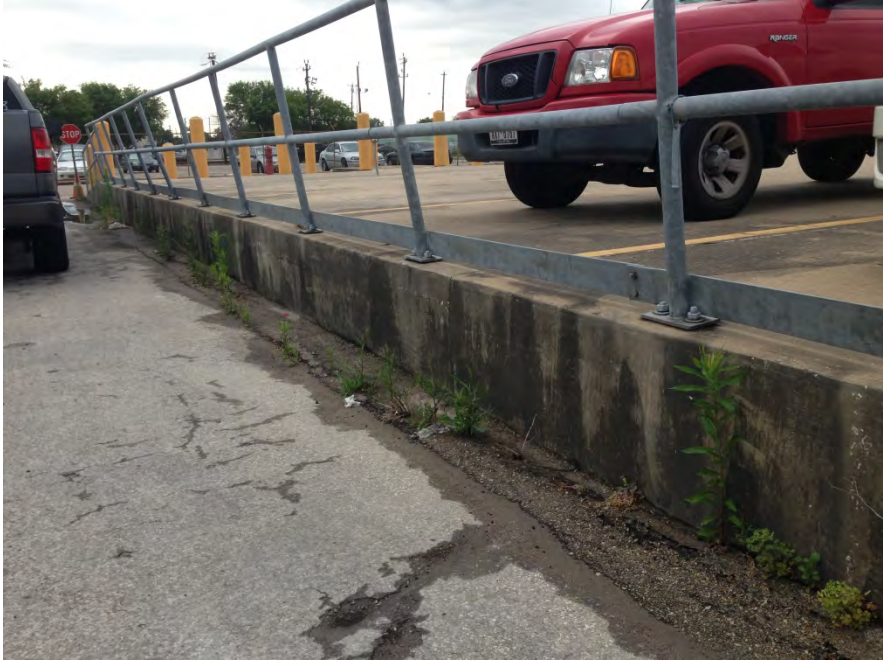
<b>SITE PHOTOGRAPH 2</b>	<p align="center"><b>South Cavalcade Site – Beazer East, Inc. Houston, Texas February 23 2012</b></p>
<p><b>Direction Photo Taken:</b></p> <p>Southwest</p> <p><b>Description:</b></p> <p>Southwest Area</p> <p>View of north edge directly along edge.</p>

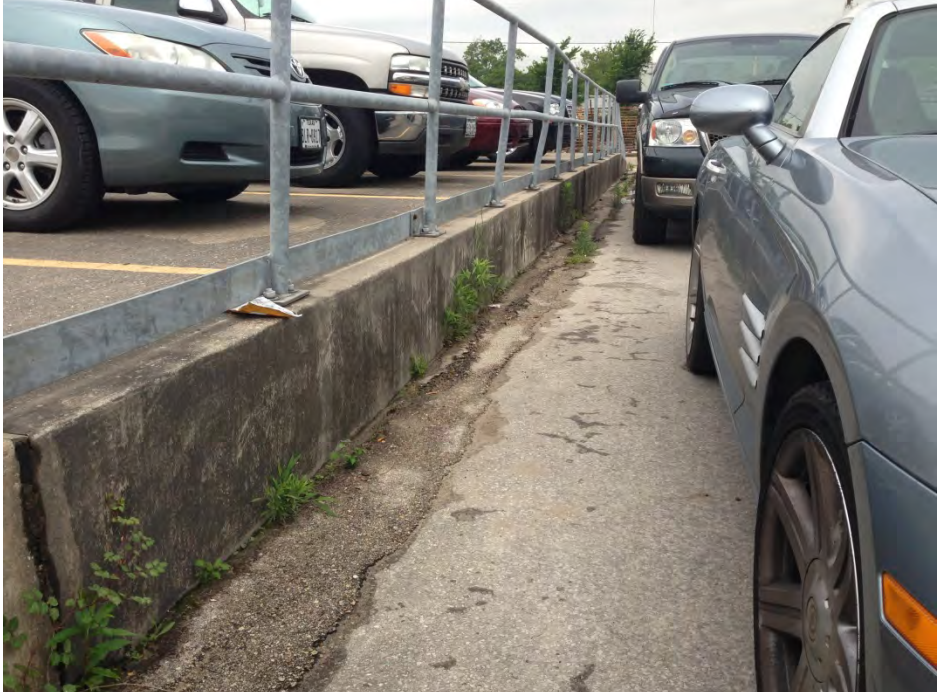
<b>SITE PHOTOGRAPH 3</b>	<b>South Cavalcade Site – Beazer East, Inc. Houston, Texas May 22, 2013</b>
<b>Direction Photo Taken:</b>  South  <b>Description:</b>  Southwest Area  View south at north edge.

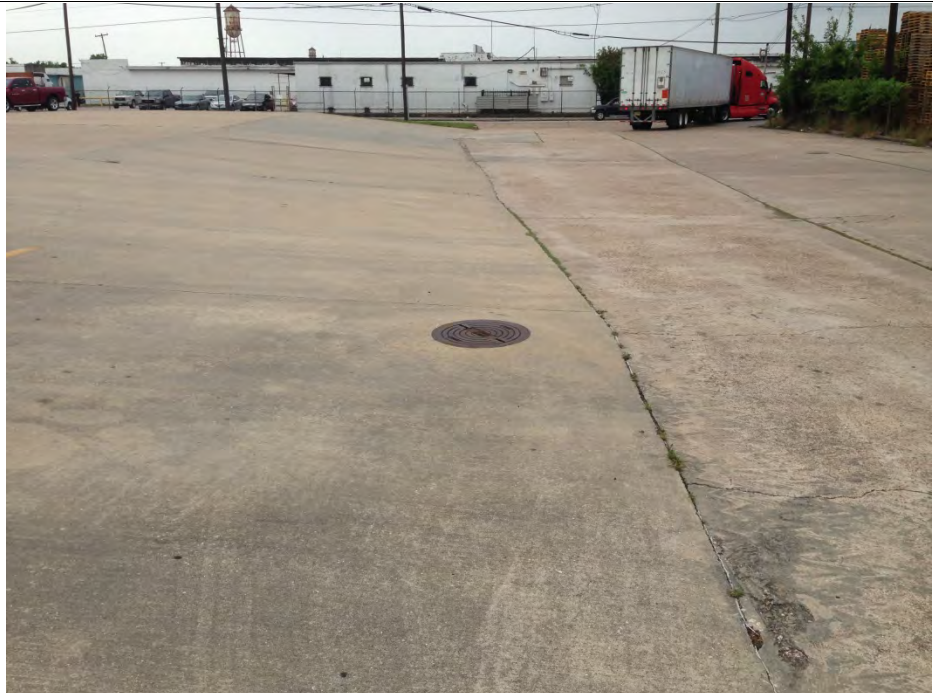
<p><b>SITE PHOTOGRAPH</b> <b>5</b></p>	<p><b>South Cavalcade Site – Beazer East, Inc.</b> <b>Houston, Texas</b> <b>May 22, 2013</b></p>
<p><b>Direction Photo Taken:</b></p> <p>North</p> <p><b>Description:</b></p> <p>Southwest Area</p> <p>West edge, view of stormwater inlet.</p>

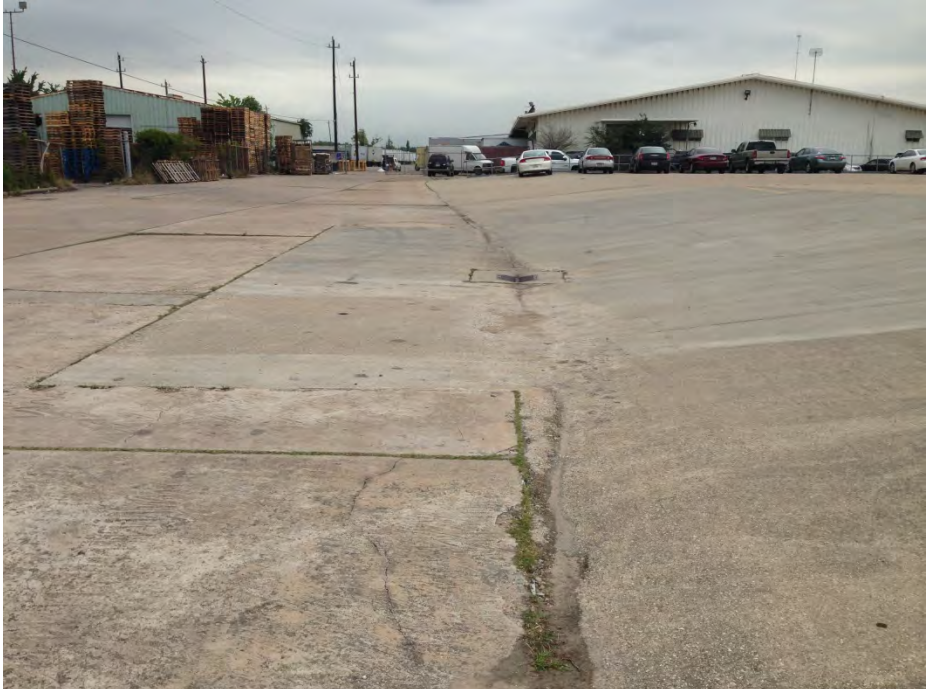
<p><b>SITE PHOTOGRAPH</b> <b>6</b></p>	<p><b>South Cavalcade Site – Beazer East, Inc.</b> <b>Houston, Texas</b> <b>May 22, 2013</b></p>
<p><b>Direction Photo Taken:</b></p> <p>East</p> <p><b>Description:</b></p> <p>Southwest Area</p> <p>South edge of cap.</p>

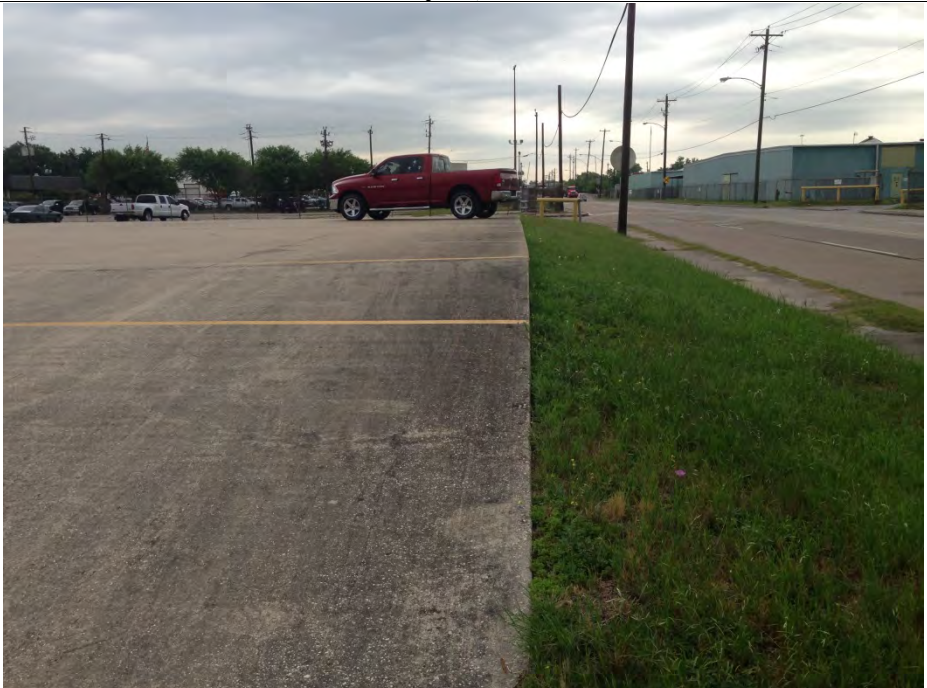
<b>SITE PHOTOGRAPH 7</b>	<b>South Cavalcade Site – Beazer East, Inc. Houston, Texas May 22, 2013</b>
<p><b>Direction Photo Taken:</b></p> <p>North</p> <p><b>Description:</b></p> <p>Southwest Area</p> <p>View of construction joint.</p>

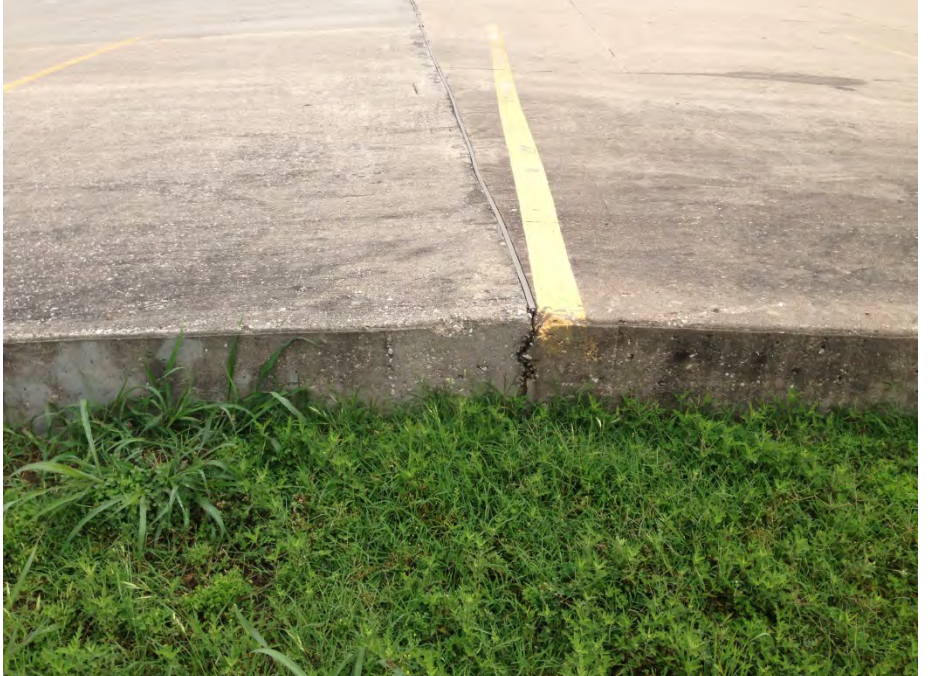
<b>SITE PHOTOGRAPH 8</b>	<b>South Cavalcade Site – Beazer East, Inc. Houston, Texas May 22, 2013</b>
<p><b>Direction Photo Taken:</b></p> <p>North</p> <p><b>Description:</b></p> <p>Southwest Area</p> <p>View of center construction joint at south edge.</p>

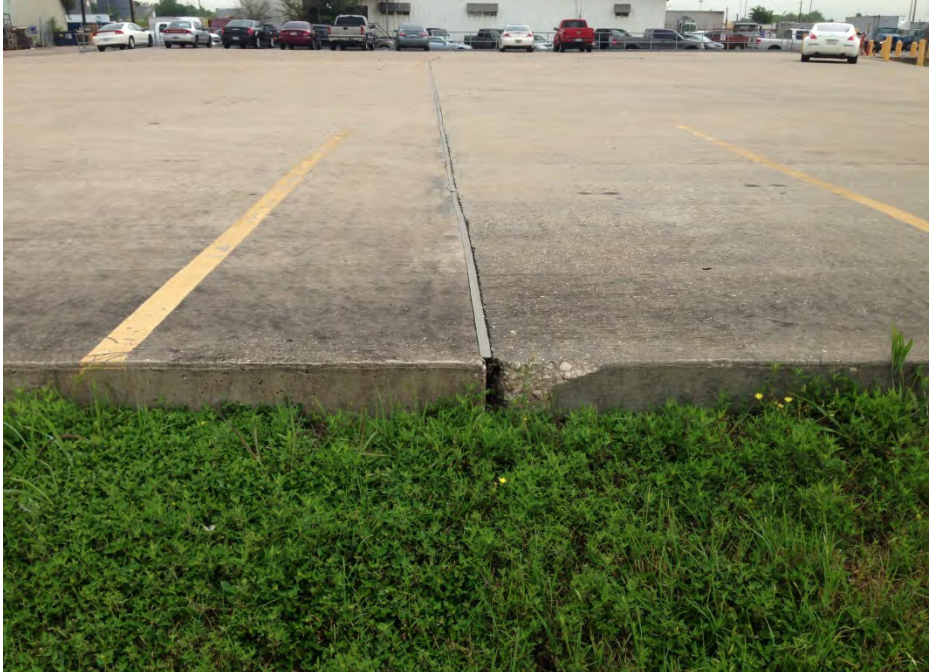
<b>SITE PHOTOGRAPH 9</b>	<b>South Cavalcade Site – Beazer East, Inc. Houston, Texas May 22, 2013</b>
<p><b>Direction Photo Taken:</b></p> <p>North</p> <p><b>Description:</b></p> <p>Southwest Area</p> <p>East edge, view of storm water inlet.</p>

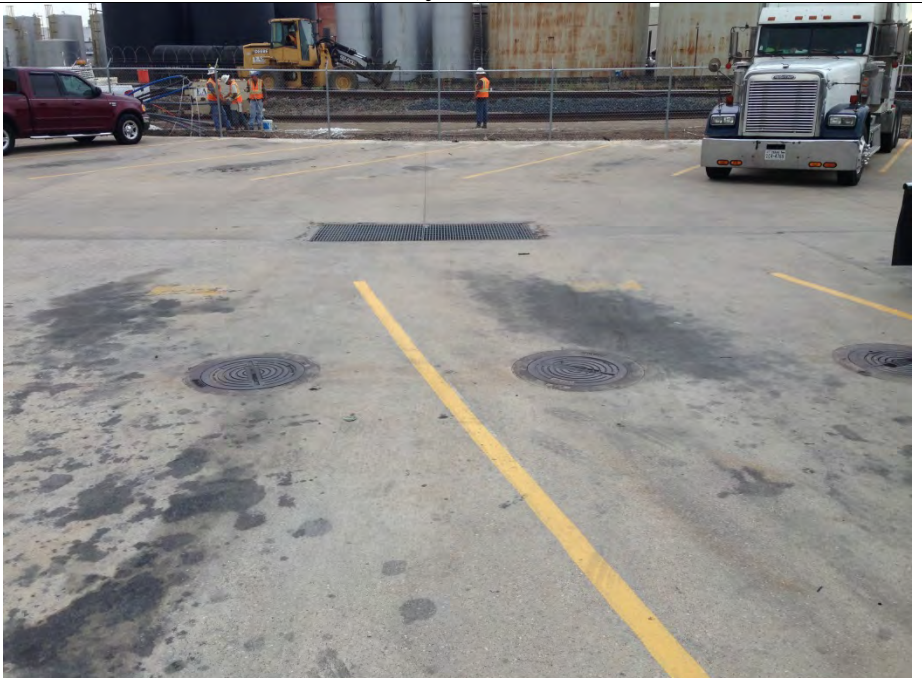
<b>SITE PHOTOGRAPH 17</b>	<p align="center"><b>South Cavalcade Site – Beazer East, Inc.</b>  <b>Houston, Texas</b>  <b>May 22, 2013</b></p>
<p><b>Direction Photo Taken:</b></p> <p>West</p> <p><b>Description:</b></p> <p>Southeast Area</p> <p>South end of cap.</p>

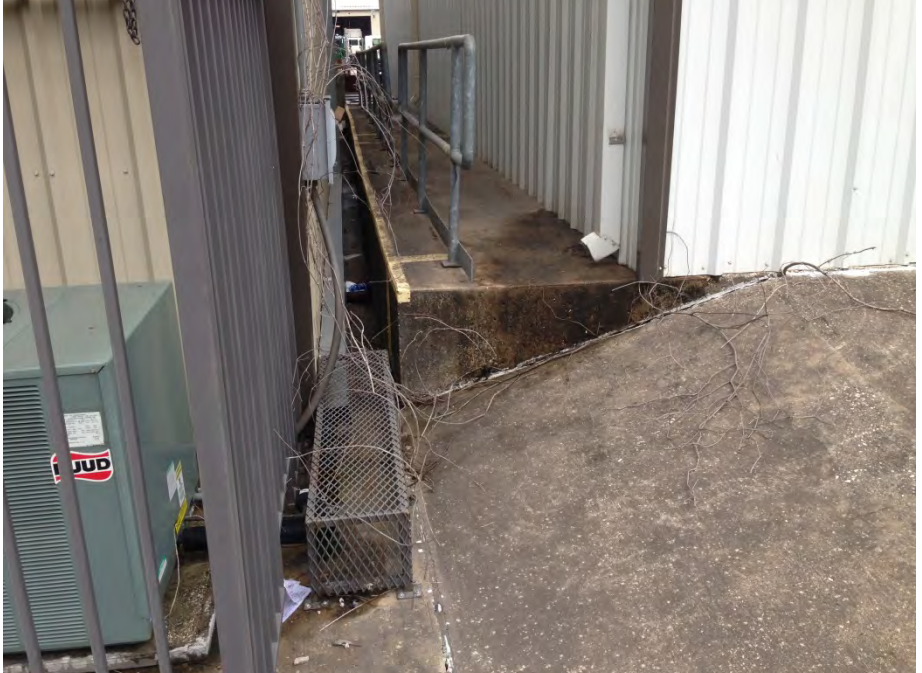
<b>SITE PHOTOGRAPH 24</b>	<b>South Cavalcade Site – Beazer East, Inc. Houston, Texas May 22, 2013</b>
<p><b>Direction Photo Taken:</b></p> <p>North</p> <p><b>Description:</b></p> <p>Southeast Area</p> <p>East slope. 2009 building.</p>

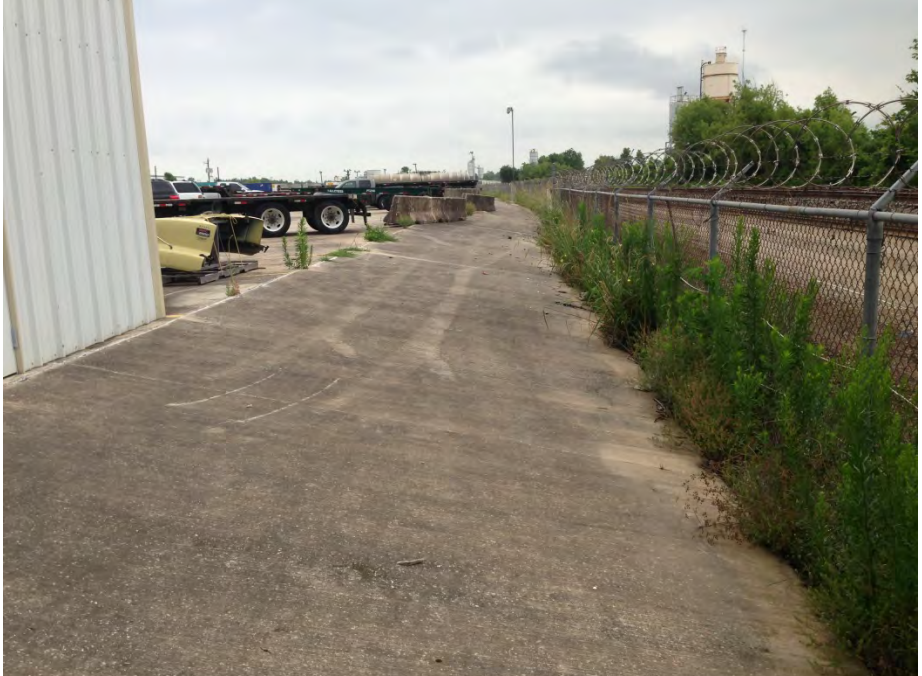
<p><b>SITE PHOTOGRAPH 25</b></p>	<p><b>South Cavalcade Site – Beazer East, Inc. Houston, Texas May 22, 2013</b></p>
<p><b>Direction Photo Taken:</b></p> <p>Northwest</p> <p><b>Description:</b></p> <p>Southeast Area</p> <p>Groundwater pump vaults at east slope.</p>

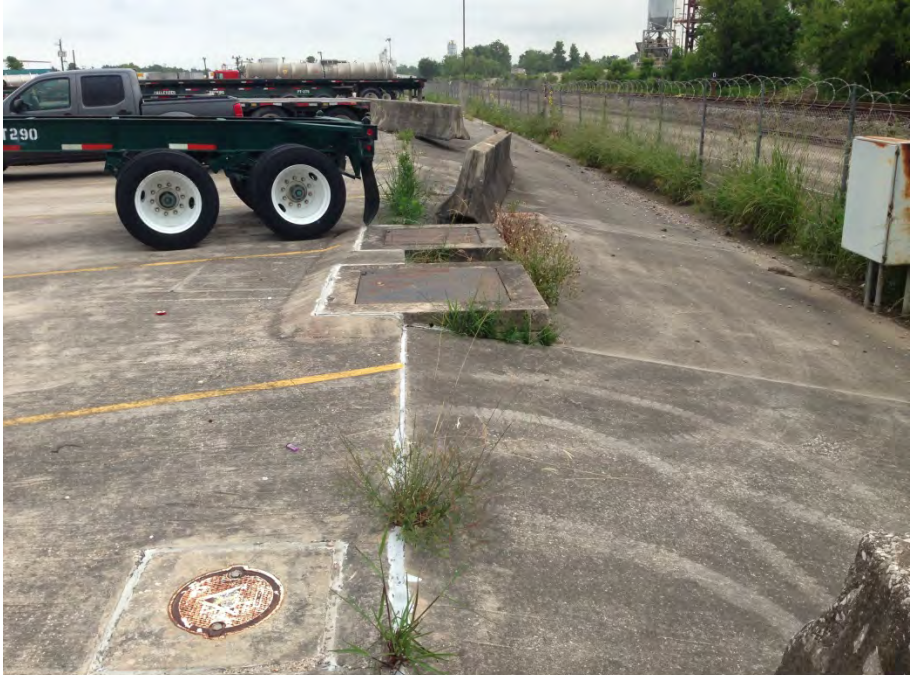
<p><b>SITE PHOTOGRAPH 26</b></p>	<p><b>South Cavalcade Site – Beazer East, Inc. Houston, Texas May 22, 2013</b></p>
<p><b>Direction Photo Taken:</b></p> <p>South</p> <p><b>Description:</b></p> <p>Southeast Area</p> <p>View from groundwater pump vaults.</p>

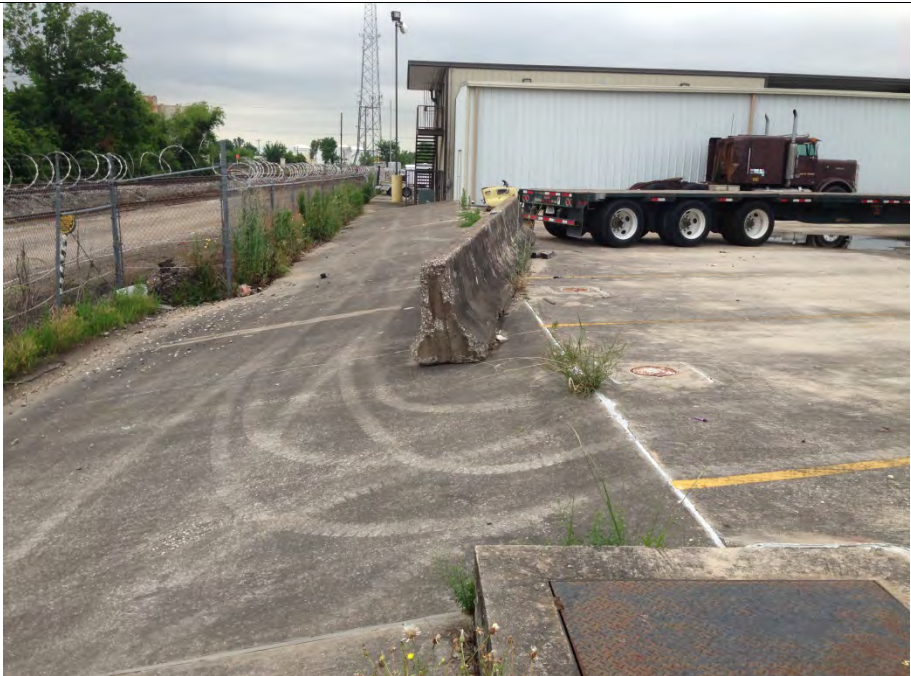
<b>SITE PHOTOGRAPH 27</b>	<b>South Cavalcade Site – Beazer East, Inc. Houston, Texas May 22, 2013</b>
<b>Direction Photo Taken:</b>  South  <b>Description:</b>  Southeast Area  Center of east slope.

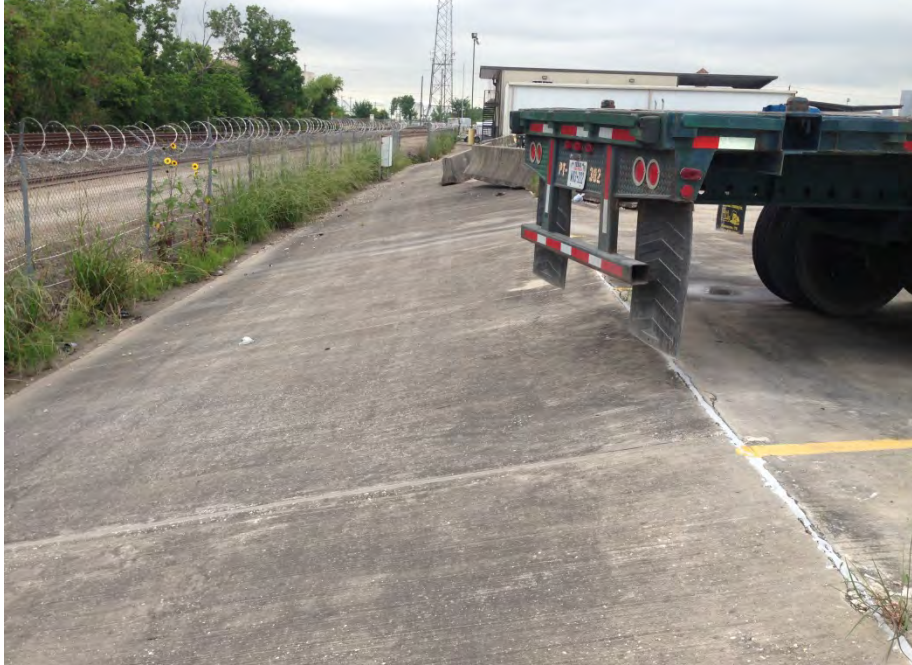
<b>SITE PHOTOGRAPH 28</b>	<b>South Cavalcade Site – Beazer East, Inc. Houston, Texas May 22, 2013</b>
<b>Direction Photo Taken:</b>  North  <b>Description:</b>  Southeast Area  Center of east slope.

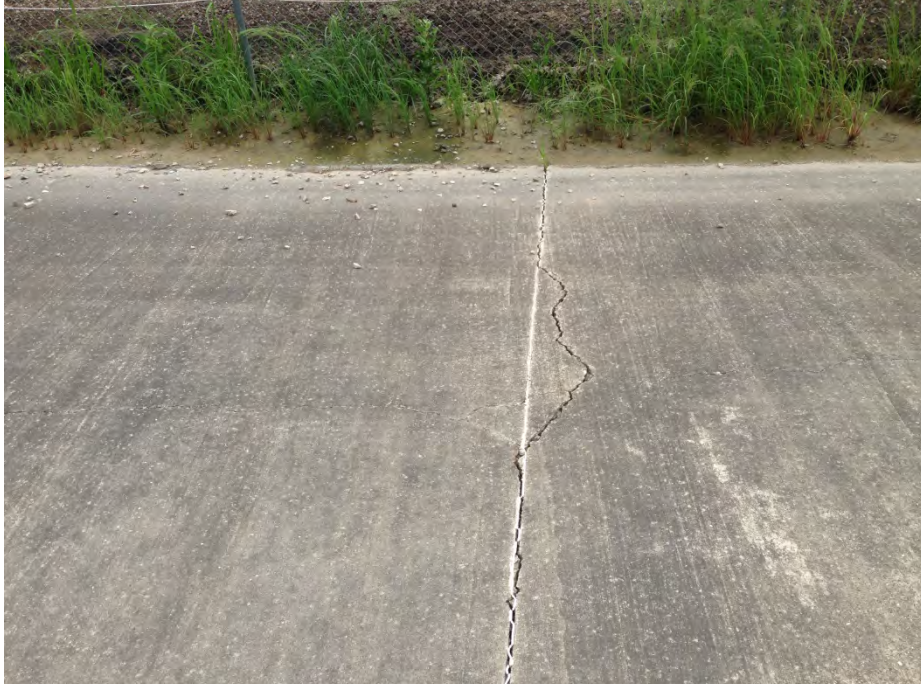
<b>SITE PHOTOGRAPH 31</b>	<b>South Cavalcade Site – Beazer East, Inc. Houston, Texas May 22, 2013</b>
<p><b>Direction Photo Taken:</b></p> <p>South</p> <p><b>Description:</b></p> <p>Southeast Area</p> <p>East slope at north end of cap.</p>

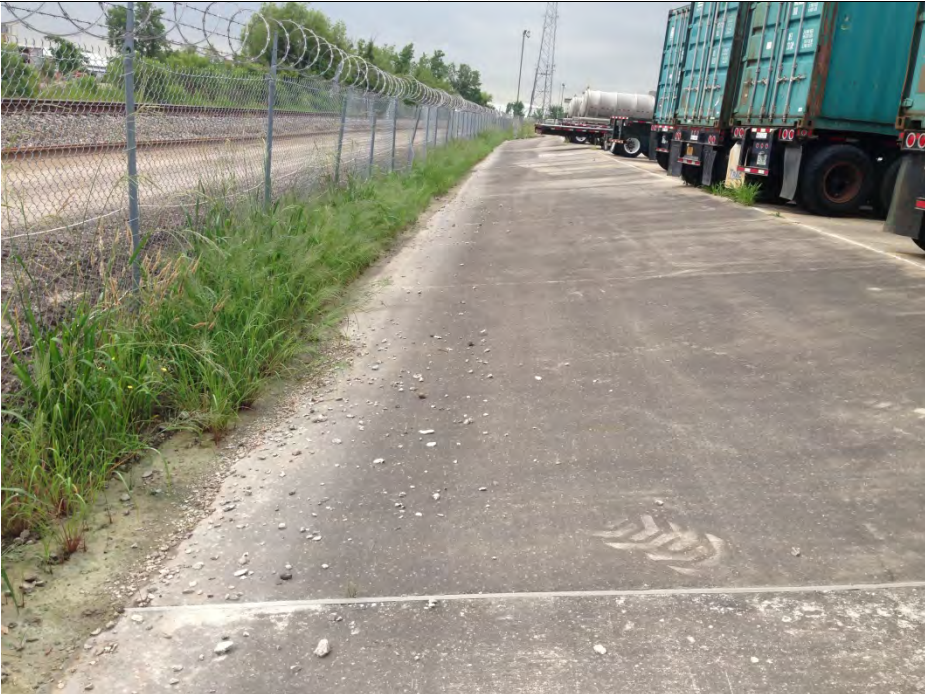
<b>SITE PHOTOGRAPH 32</b>	<b>South Cavalcade Site – Beazer East, Inc. Houston, Texas May 22, 2013</b>
<p><b>Direction Photo Taken:</b></p> <p>South</p> <p><b>Description:</b></p> <p>Southeast Area</p> <p>View of west edge.</p>

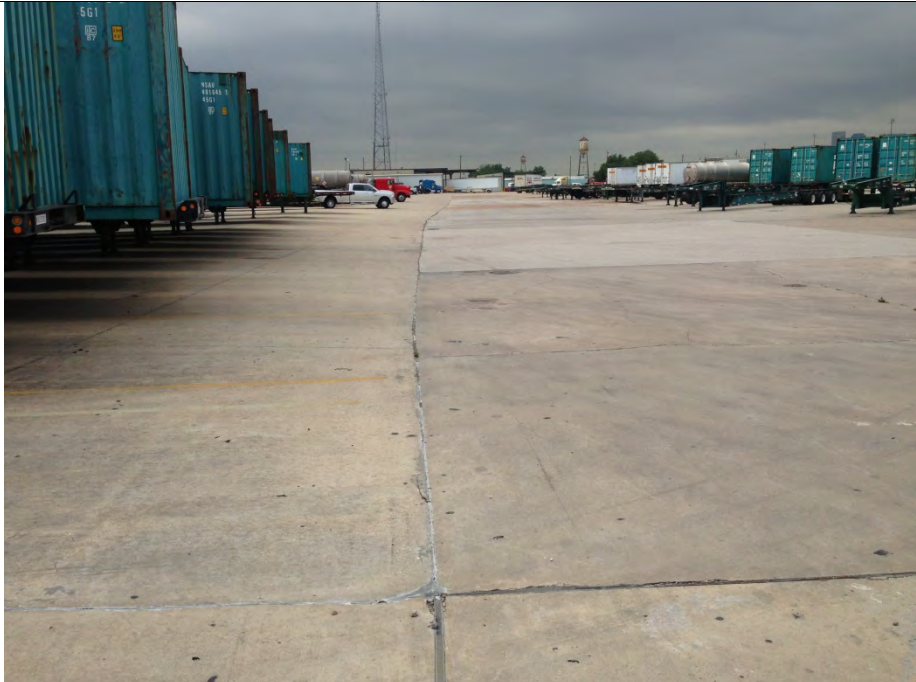
<p><b>SITE PHOTOGRAPH 33</b></p>	<p><b>South Cavalcade Site – Beazer East, Inc. Houston, Texas May 22, 2013</b></p>
<p><b>Direction Photo Taken:</b></p> <p>South</p> <p><b>Description:</b></p> <p>Southeast Area</p> <p>Typical stormwater inlet, west cap edge.</p>

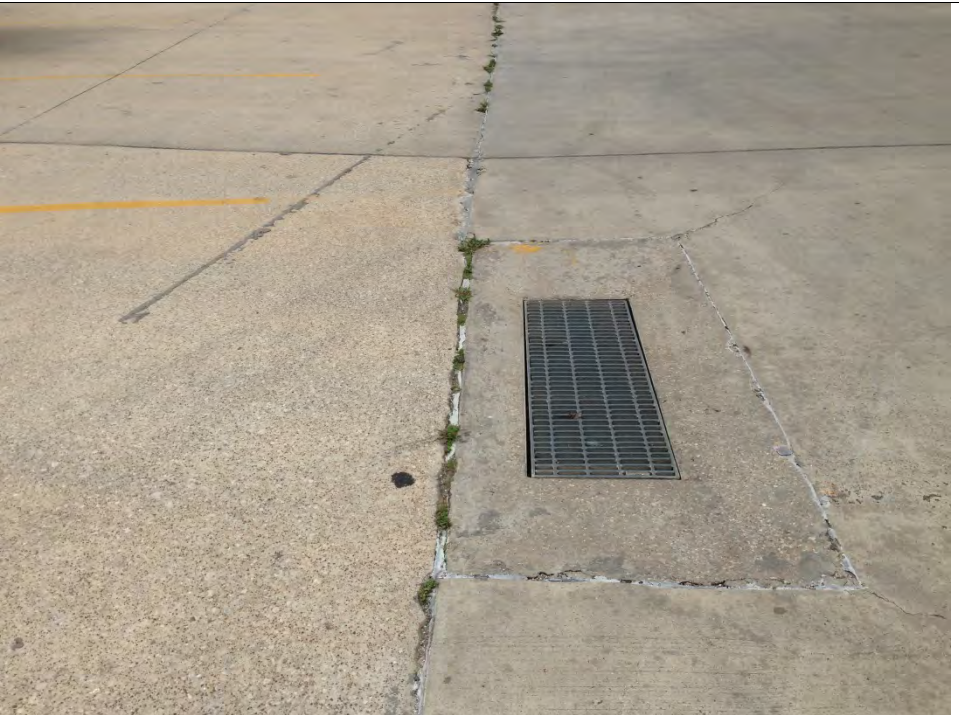
<p><b>SITE PHOTOGRAPH 34</b></p>	<p><b>South Cavalcade Site – Beazer East, Inc. Houston, Texas May 22, 2013</b></p>
<p><b>Direction Photo Taken:</b></p> <p>East</p> <p><b>Description:</b></p> <p>Southeast Area</p> <p>Across cap from west edge.</p>

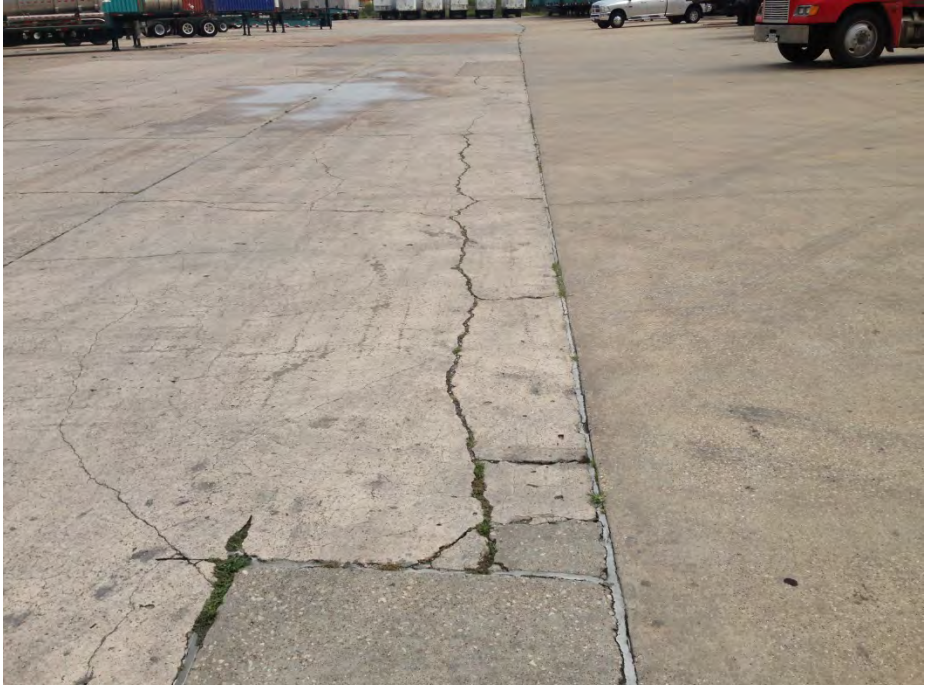
<b>SITE PHOTOGRAPH 36</b>	<b>South Cavalcade Site – Beazer East, Inc. Houston, Texas May 22, 2013</b>
<p><b>Direction Photo Taken:</b></p> <p>East</p> <p><b>Description:</b></p> <p>Southeast Area</p> <p>Across cap at west edge.</p>

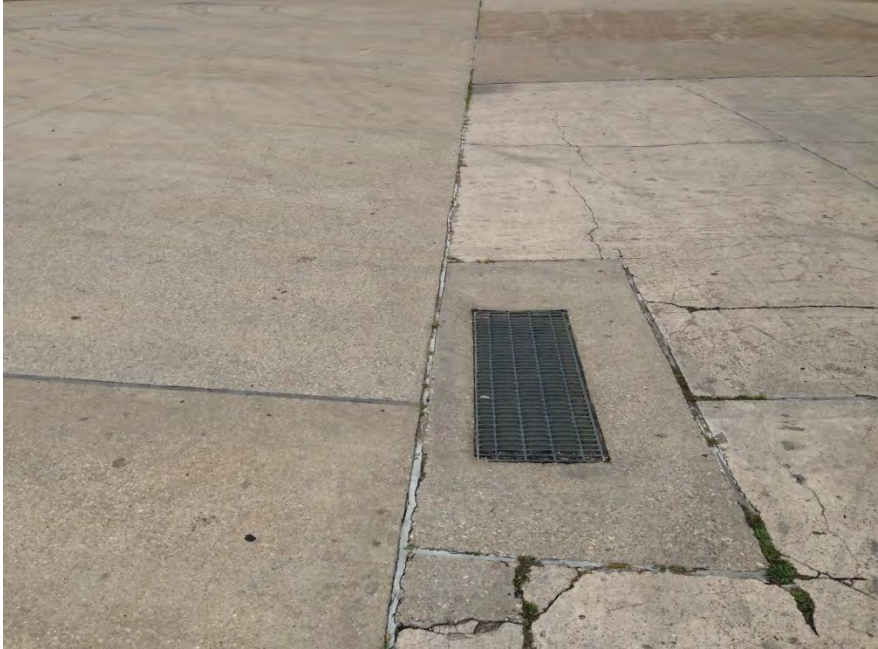
<b>SITE PHOTOGRAPH 38</b>	<b>South Cavalcade Site – Beazer East, Inc. Houston, Texas May 22, 2013</b>
<b>Direction Photo Taken:</b>  South  <b>Description:</b>  Southeast Area  West edge.

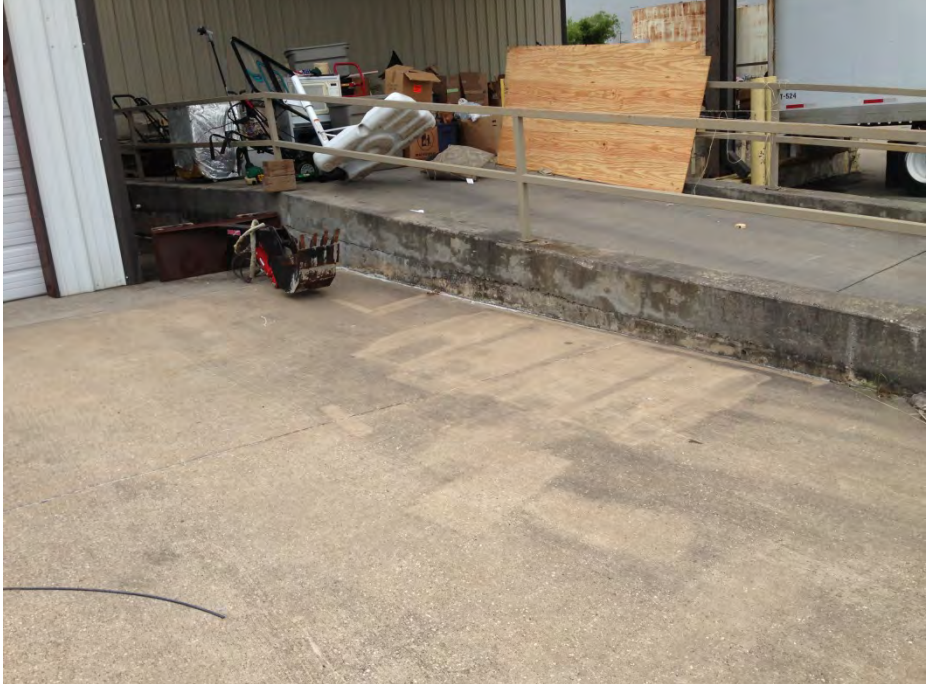
<b>SITE PHOTOGRAPH 40</b>	<b>South Cavalcade Site – Beazer East, Inc. Houston, Texas May 22, 2013</b>
<p><b>Direction Photo Taken:</b></p> <p>North</p> <p><b>Description:</b></p> <p>Southeast Area</p> <p>West edge area of loading dock.</p>
